NOTE: REFER TO STRUCTURAL NOTES AND SPECIFICATIONS FOR MORE INFORMATION ON TUCK POINTING AND MASONRY REPAIR PROCEDURES AND REQUIREMENTS

Deep Tuck Pointing of Stone Masonry Walls

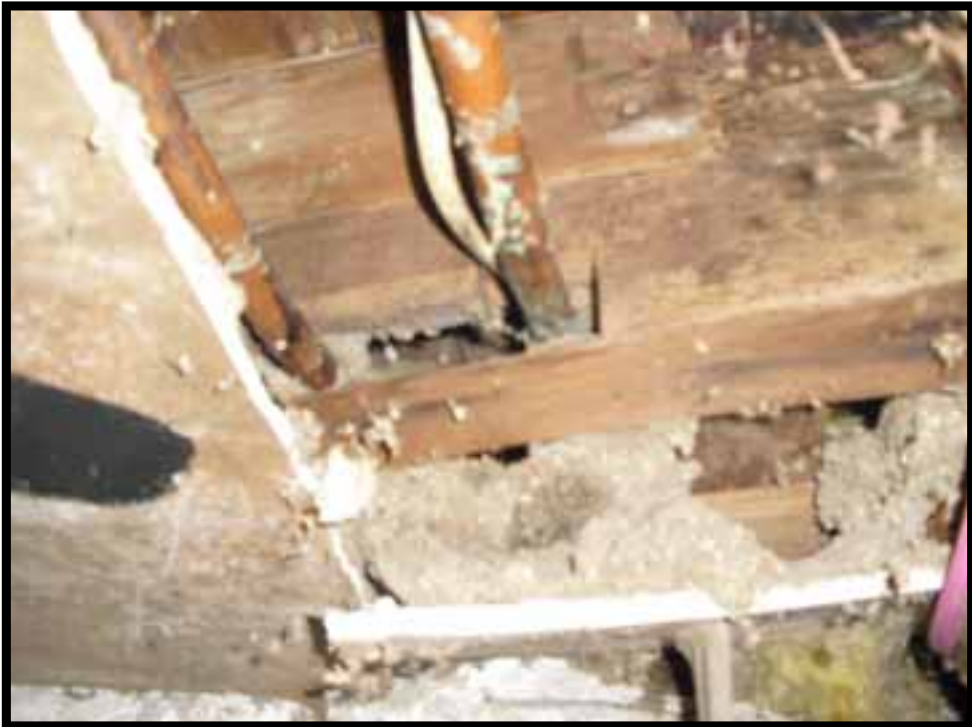
8. PLUMBERS HAVE DAMAGED FIRST FLOOR JOISTS IN SOUTHWEST CORNER ROOM.

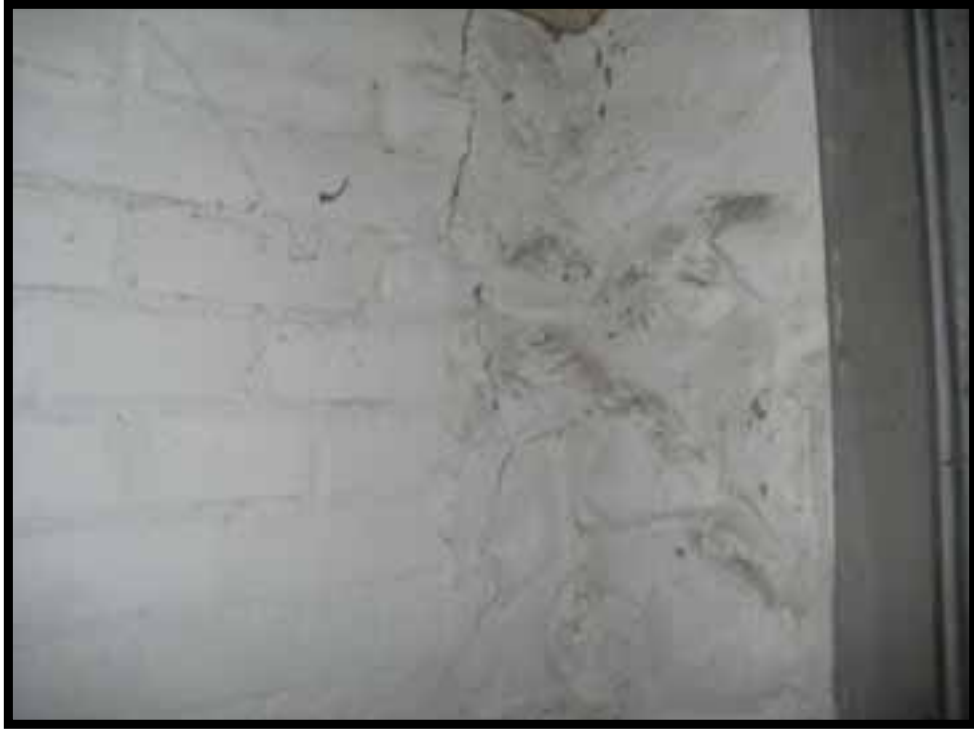
9. CRACKS BETWEEN SOUTHWEST CHIMNEY BRICK AND STONE FOUNDATION WALL.

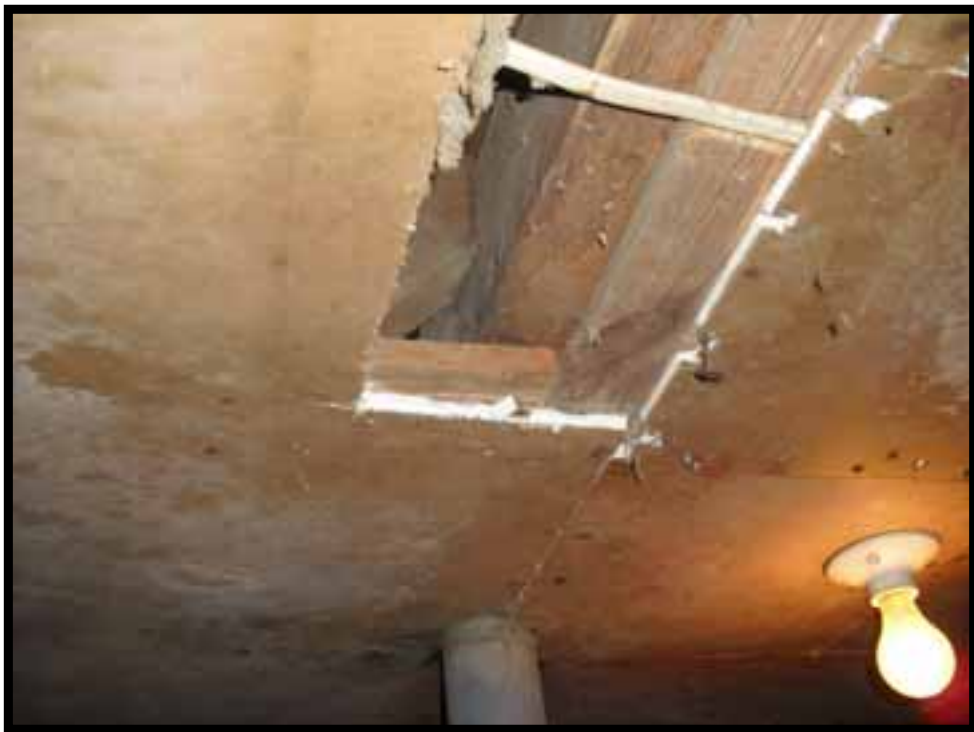
10. CENTRAL TIMBER BEAM IN S-W CORNER BASEMENT ROOM SPANS EAST WEST AND IS SUPPORTED BY PIPE COLUMN AND BRICK PIER. JOISTS MORTISE IN.

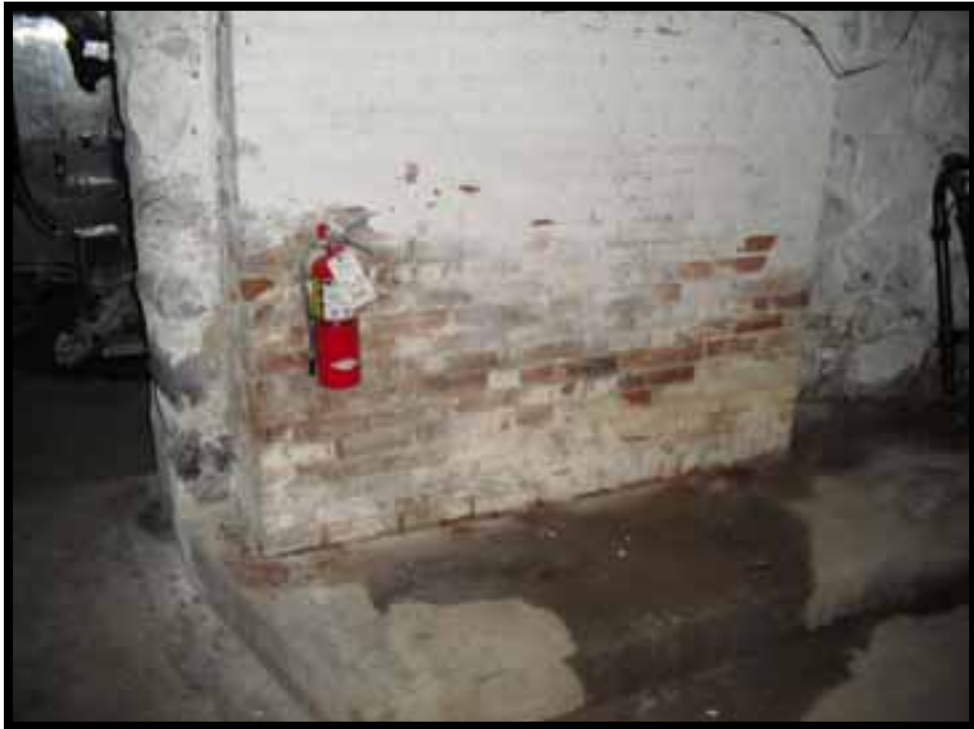
21. WATER LEAKING FROM NORTH WEST CHIMNEY.

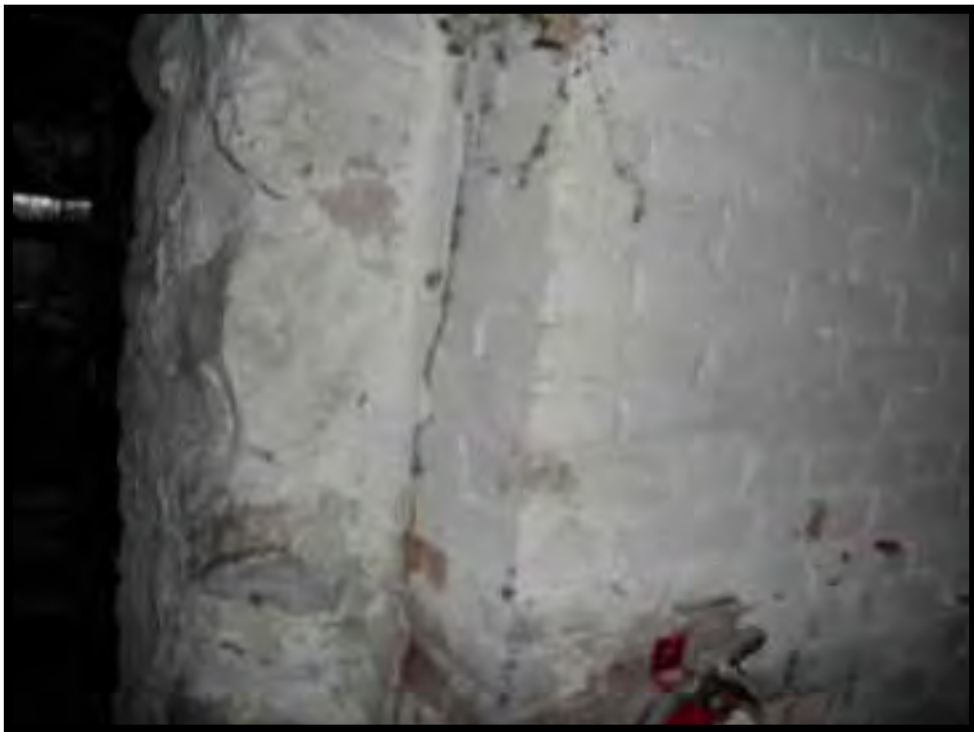
22. CRACK BETWEEN NORTH WEST BRICK CHIMNEY AND
STONE FOUNDATION WALL.

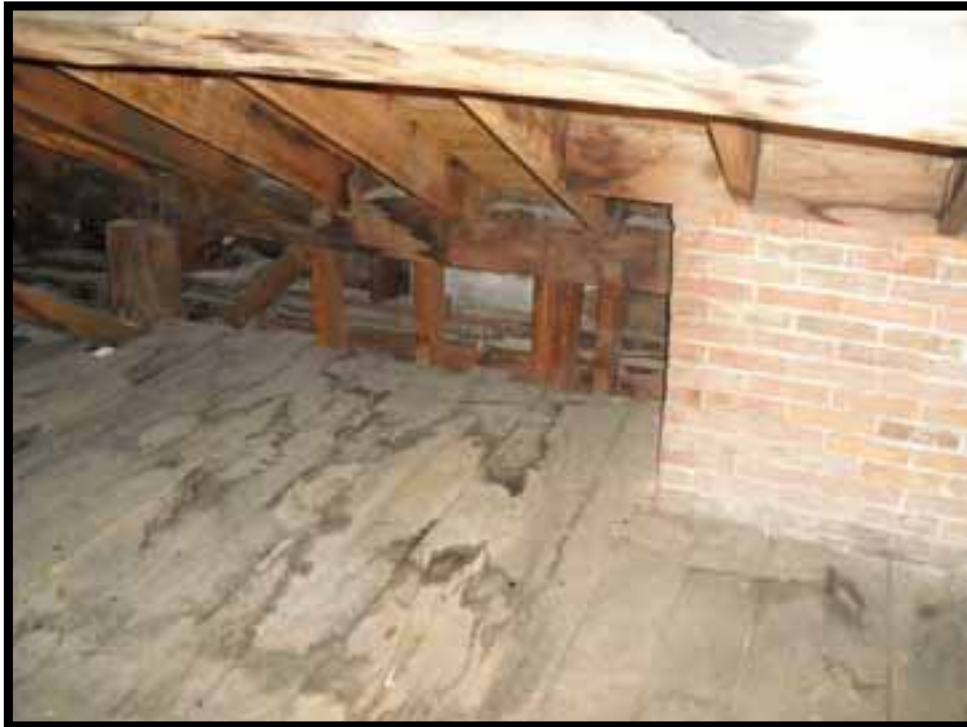
29. ATTIC FLOOR BOARDS AND ROOF FRAMING SHOW EVIDENCE OF PAST WATER LEAKAGE BUT WERE DRY DURING MY INSPECTION.

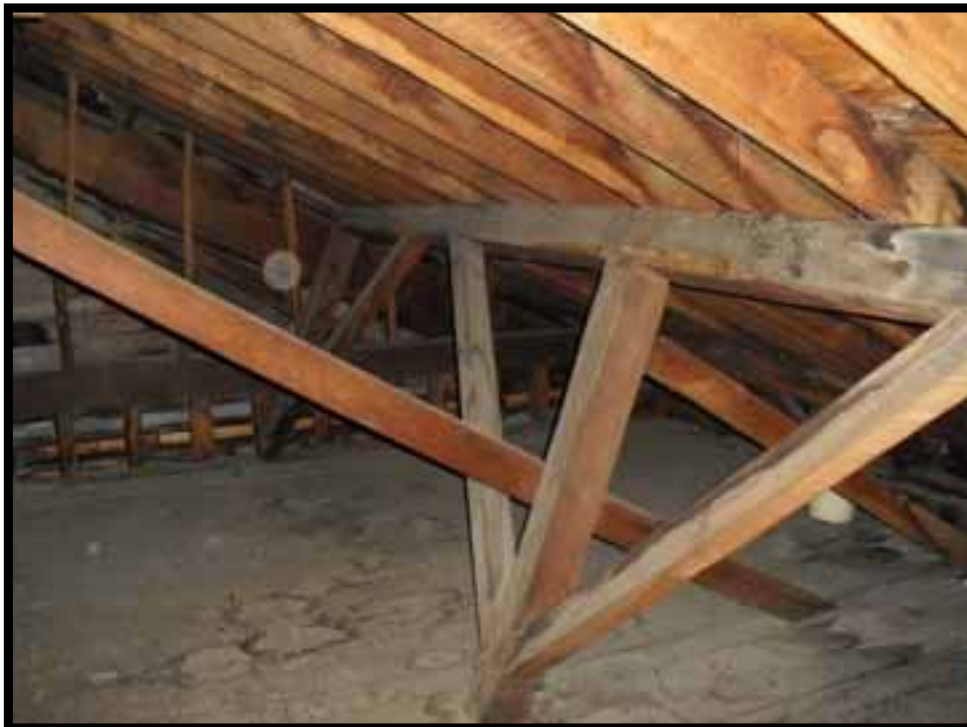
30. LOOKING SOUTH EAST AT ROOF FRAMING IN SOUTH EAST CORNER OF ATTIC.

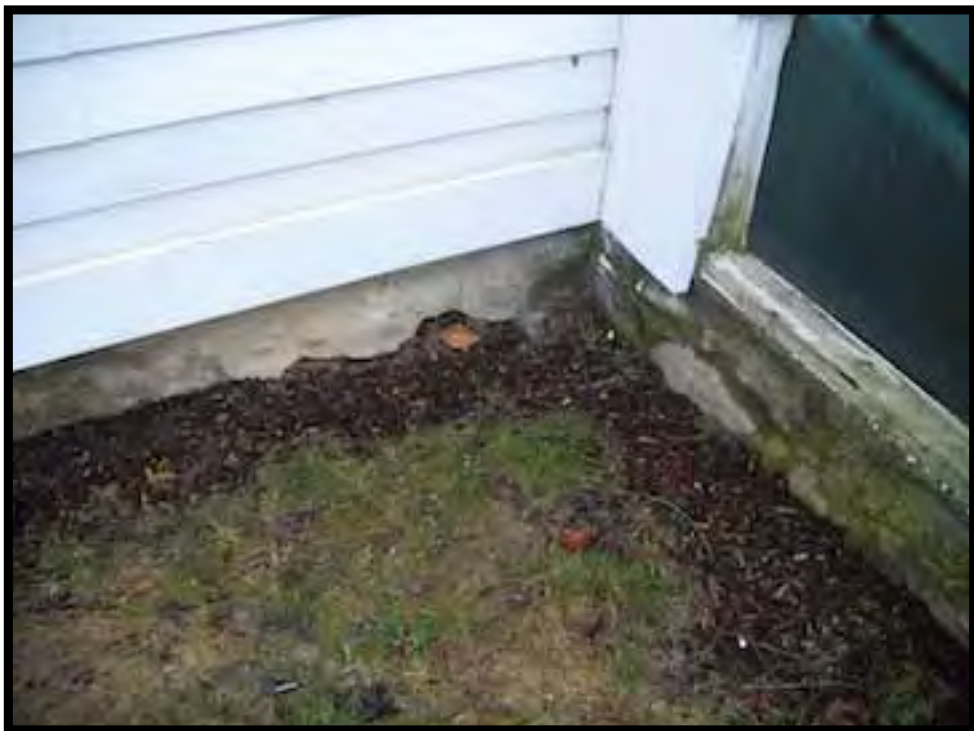
68. FOUNDATION ADJACENT TO CELLAR DOOR.

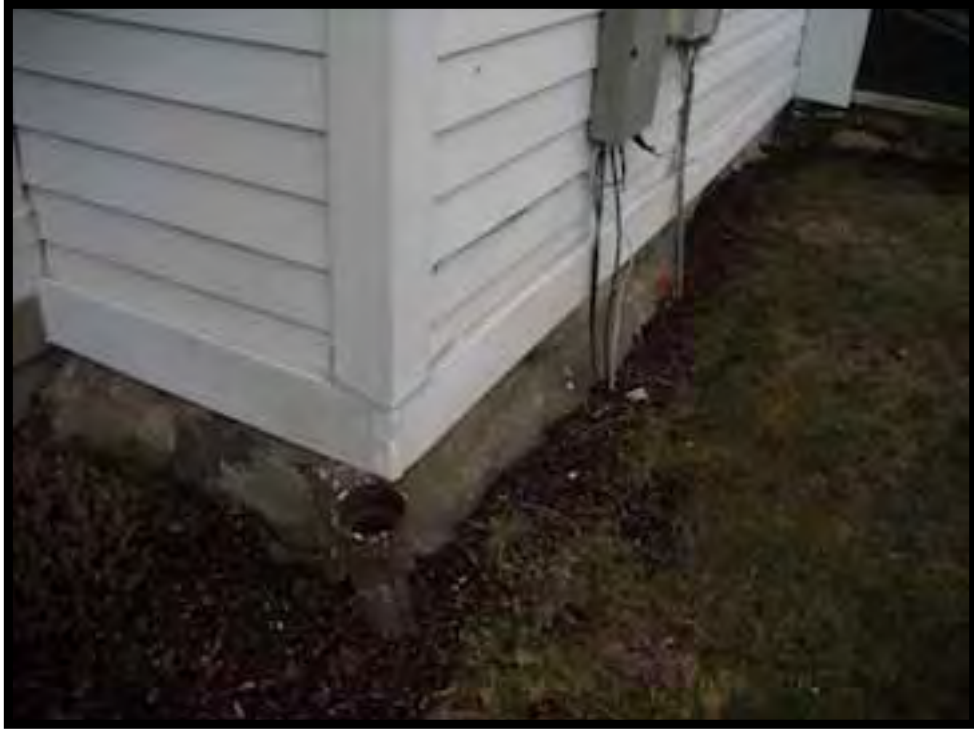
69. FOUNDATION AT NORTH WEST CORNER OF SOUTH WEST WING.

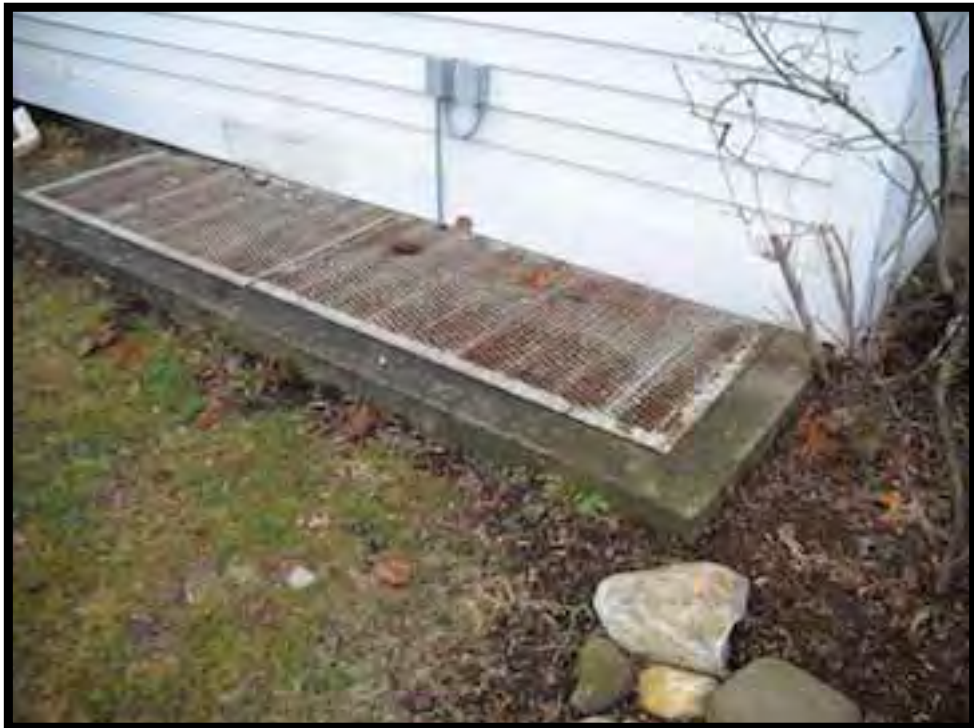
70. SOUTH WEST CORNER OF NORTH WEST WING.
